Friends of Scotchmans Creek and Valley Reserve Inc

Waterwatch Report 23 June 2019

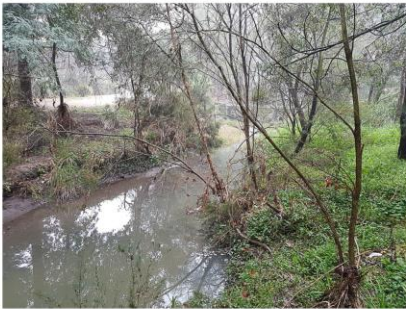
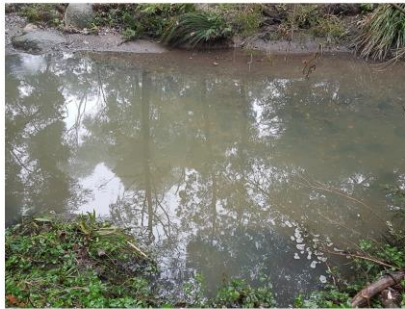
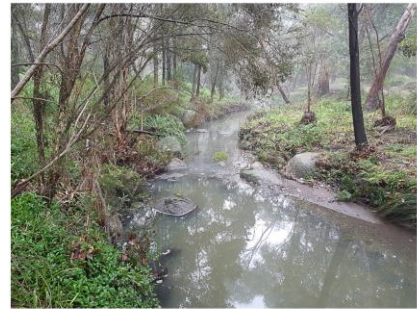
Site 1a upstream 20190623_095003

Site 1a across 20190623_095020

Site 1a downstream 20190623_095013

- Site 1a, 23 June 2019. Very little in-stream vegetation, and continued deposition of sand and gravel along the site-area stream bed. Erosion appears more extensive than last year. Site rating unchanged, Fair.
- Site 1b, 23 June 2019. In stream vegetation patchy but reasonably extensive. Active erosion and deposition occurring along the site area. Verge and bank vegetation still extensive and of reasonably good quality. Site rating unchanged, Fair.

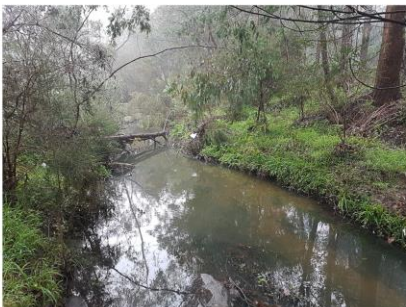
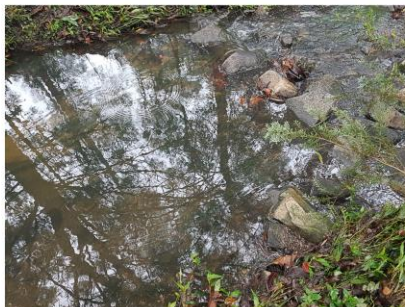
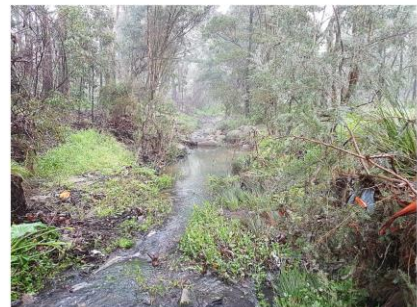
Site 1b upstream 20190623_095245

Site 1b across 20190623_095306

Site 1b downstream 20190623_095254
