Friends of Scotchmans Creek and Valley Reserve Inc

Waterwatch Report 22 January 2023

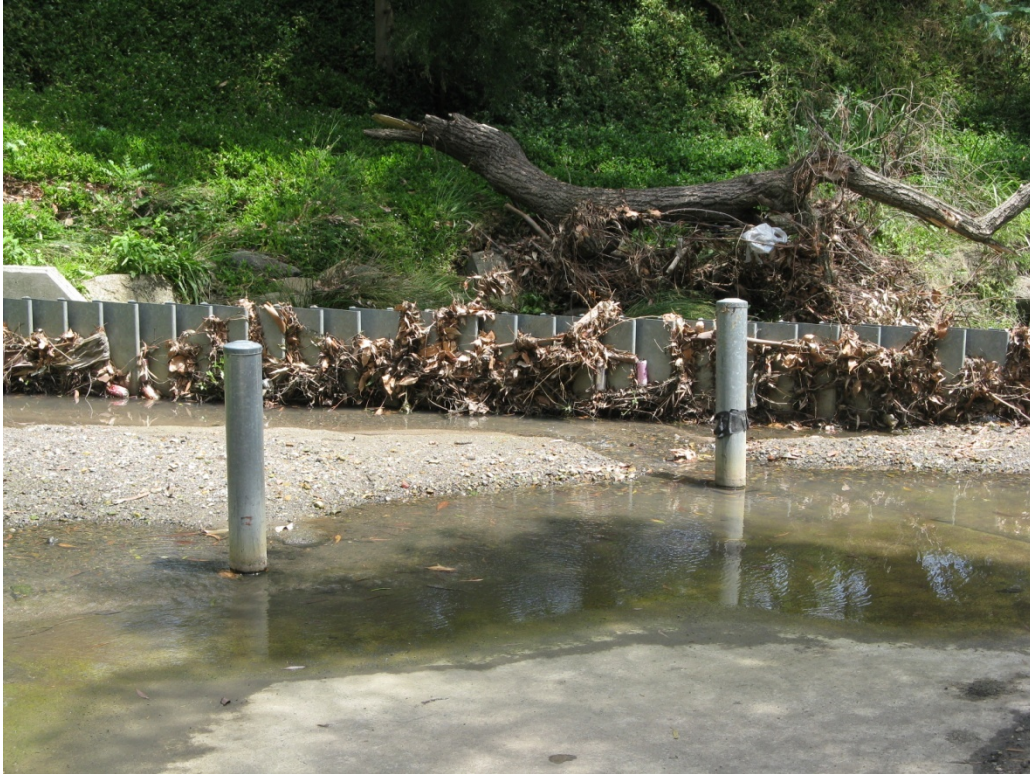
- There was abundant damselfly larvae at Site 2. It was observed that there was quite a number of adult (flying) dragonflies at Site 1b.
- The invertebrate survey ratings ('Waterwatch' method) were Very Good and Fair for both the downstream sites.
- Valley Creek water level was low and stagnant, oxygen level was Poor. There was a large number of mosquito larvae counted.
- Milky coloured water at Site 1a, at first suspected sewerage spill and reported to the EPA. However, ammonium test results were zero.

Fred went to look at the site at 2:20 pm. The creek is flowing quite slowly (much slower than site 1b), cloudy water (ducks feet visible), no smell. He took a photo at the litter trap (see below) - all the 1a flow is in the shallow flow beside the right-hand post. Some rocks at the bridge are wet some height above the level of the water that he saw.
