***FRIENDS OF SCOTCHMANS CREEK  
AND VALLEY RESERVE INC.***

**WATERWATCH REPORT, AGM 2025**

# 2021-2025 Upstream Water Quality Site Summary

# 2021-2025 Downstream Water Quality Site Summary

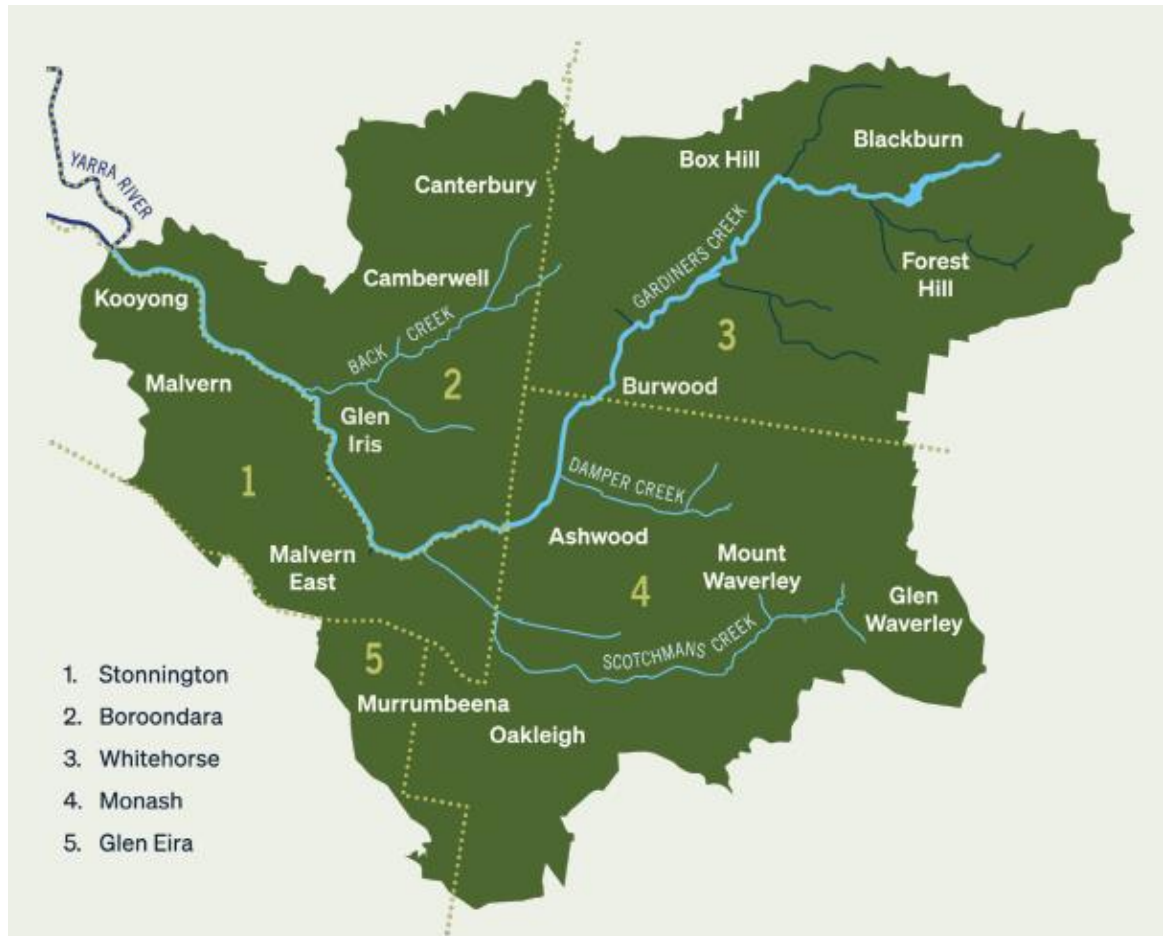
# Gardiners Creek (KooyongKoot) catchment

112 km<sup>2</sup> coverage

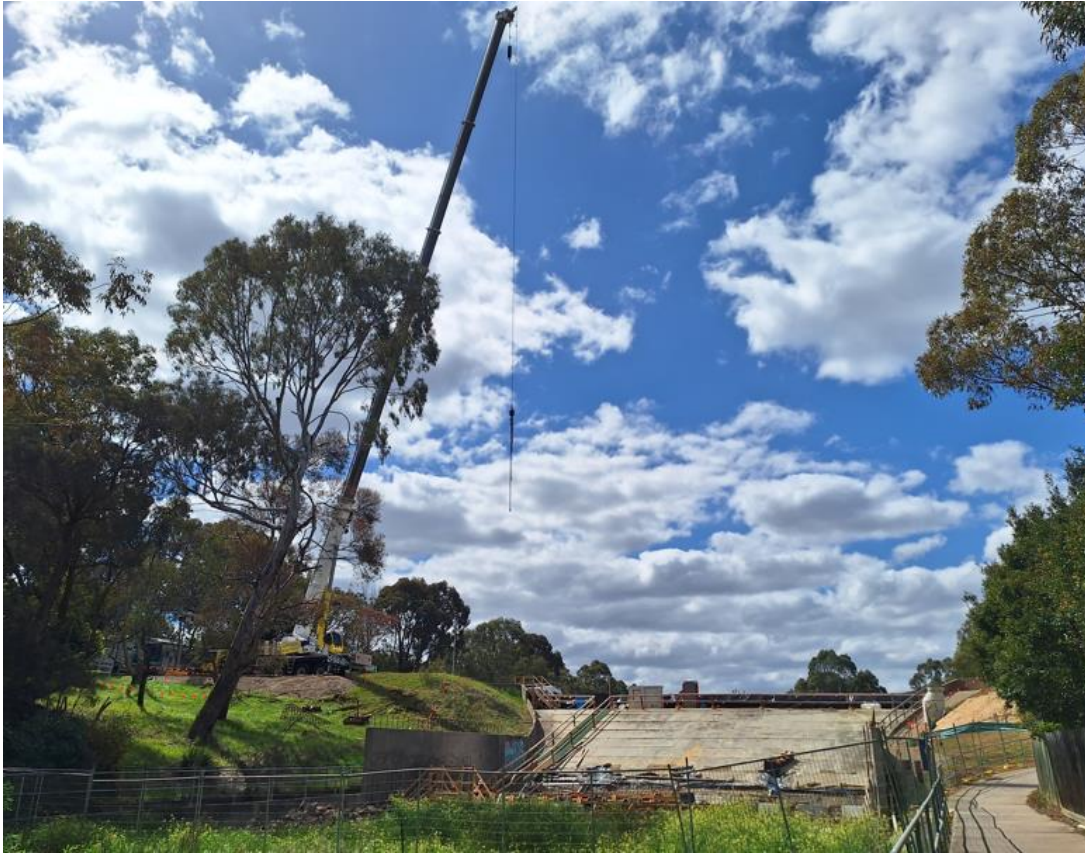
# Waverley Road Retarding Basin 7Oct2025

Construction commences on the spillway. Works will be completed in several different stages. Removal the existing concrete slabs that make up the spillway with the help of a 250-tonne crane. The spillway will then be re-built and the crane removed from site.

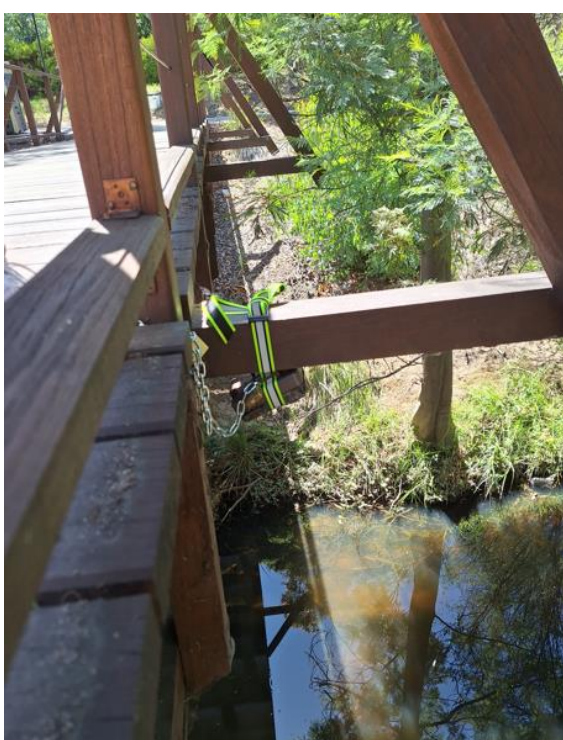
| | Bank Erosion<br>Stability | Bank<br>Vegetation | In Stream<br>Cover | Riffles Pools<br>Bends | Verge<br>Vegetation |
|---|---|---|---|---|---|
| August 2021 | Fair | Fair | Good | Good | Good |
| Weedy ground cover. One area cleared, likely sprayed prior to replanting. Good native overstorey. | | | | | |

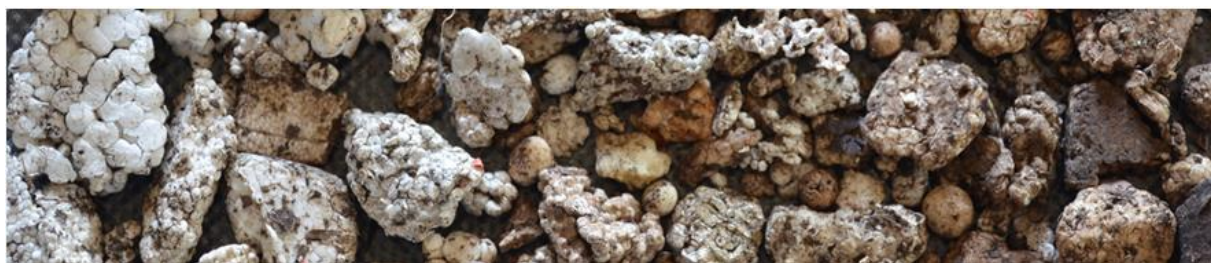
Work undertaken by the Yarra River Keeper in 2020 and published online in 2022 identified **expanded polystyrene (EPS) as the most prevalent macroplastic litter form present in the surface waters of the Yarra River.**
