## Friends of Scotchmans Creek and Valley Reserve Inc

### Waterwatch Report 22 July 2018

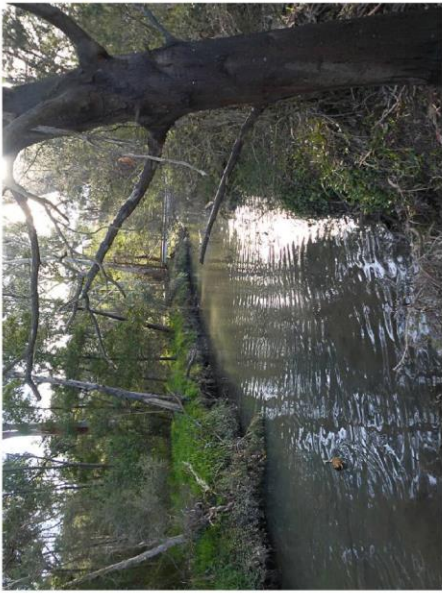
Scotchmans Creek Site 2 Upstream

- Photographs illustrating the habitat typical of sites 2 and 3 (Scotchmans Ck and Valley Ck at Regent St) are appended below.
  - The native vegetation along Scotchmans Ck is recovering after removal of the willows. 2000 more native plants were put in during a recent working bee. Localised bank erosion is occurring.
  - The south bank of Valley Ck remains very weedy, while the verge behind it has improving native vegetation. The north side has good native vegetation.
- The water chemistry test results were Fair to Excellent except for
  - Poor phosphorus level at site 2 (Scotchmans Creek).
  - Degraded ammonium level at site 1a (Scotchmans Ck upstream) and Poor at site 2 (Scotchmans Ck downstream).
  - Poor turbidity levels at all sites except Valley Ck.
