## Friends of Scotchmans Creek and Valley Reserve Inc

### Waterwatch Report 27 June 2021

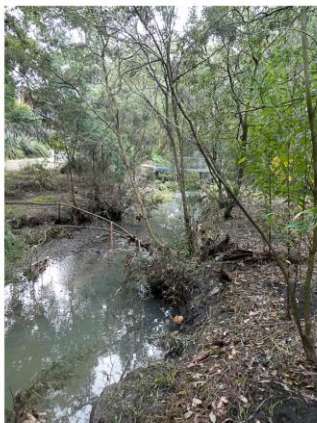
Site 1a Upstream P1040103

Site 1a (Scotchmans Ck between Turner Crt and Crosby Drive): Little to no instream vegetation, streambed is mainly sand and angular gravel. Bank vegetation is now established native species from active revegetation program. Moderate bank erosion in areas not protected by large boulders. A large flow event

within the last week increased water depth by ~1.5m and flushed leaf litter etc from banks. Water level back to low flow at time of assessment.

The Habitat Rating was 22/40, Fair.

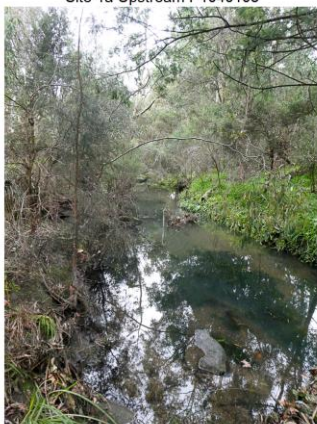
Site 1b Upstream P1040106

Site 1b (Glen Waverley Drain at confluence with Scotchmans Ck): Overstorey predominantly native (revegetated) provides extensive cover and shading across channel but understorey is very weedy. Frequent large clumps of instream vegetation. Sand and gravel substrate with introduced large boulders creating riffles and controlling erosion. Banks largely protected but some erosion on northern bank. High flow event within last week increased depth to ~0.5m which has flushed leaf litter from low banks.

The Habitat Rating was 27/40, Fair
